Towards a restoration of Brill Windmill

PROJECT UPDATE: DECEMBER 2008

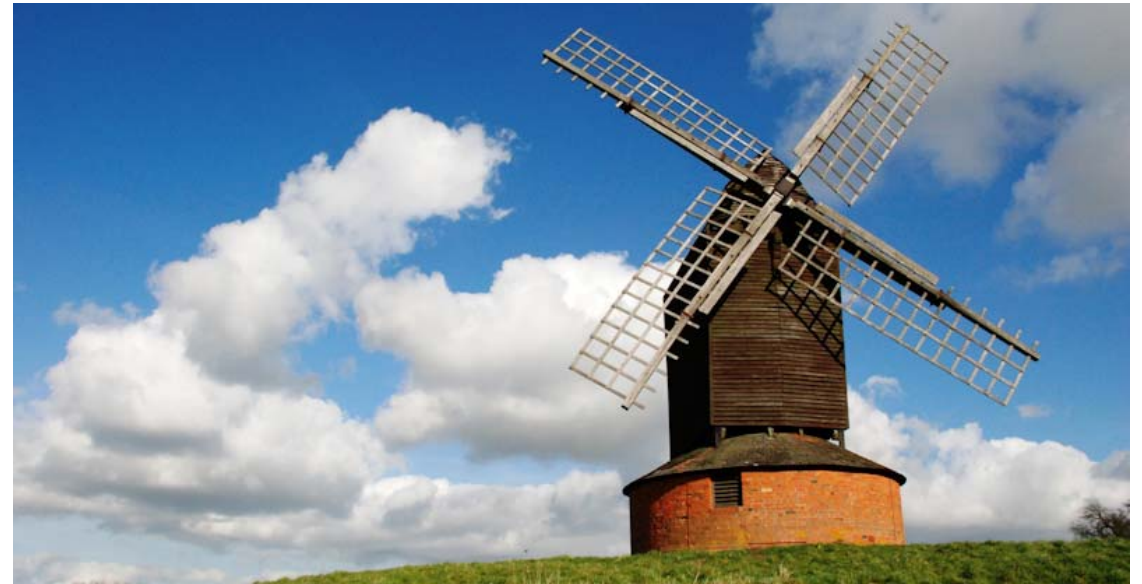
Specialist mill contractors (IJP Building Conservation) make an early morning start on the first day of works to the mill.

The early types of post mill were not fitted with a fantail or shuttered sails and therefore had to be 'luffed' or turned to face the wind by means of a tail pole. The tail pole was one of the first things to be removed from the mill.

Inset photo shows the state of weathering on the upper face of the tail post.

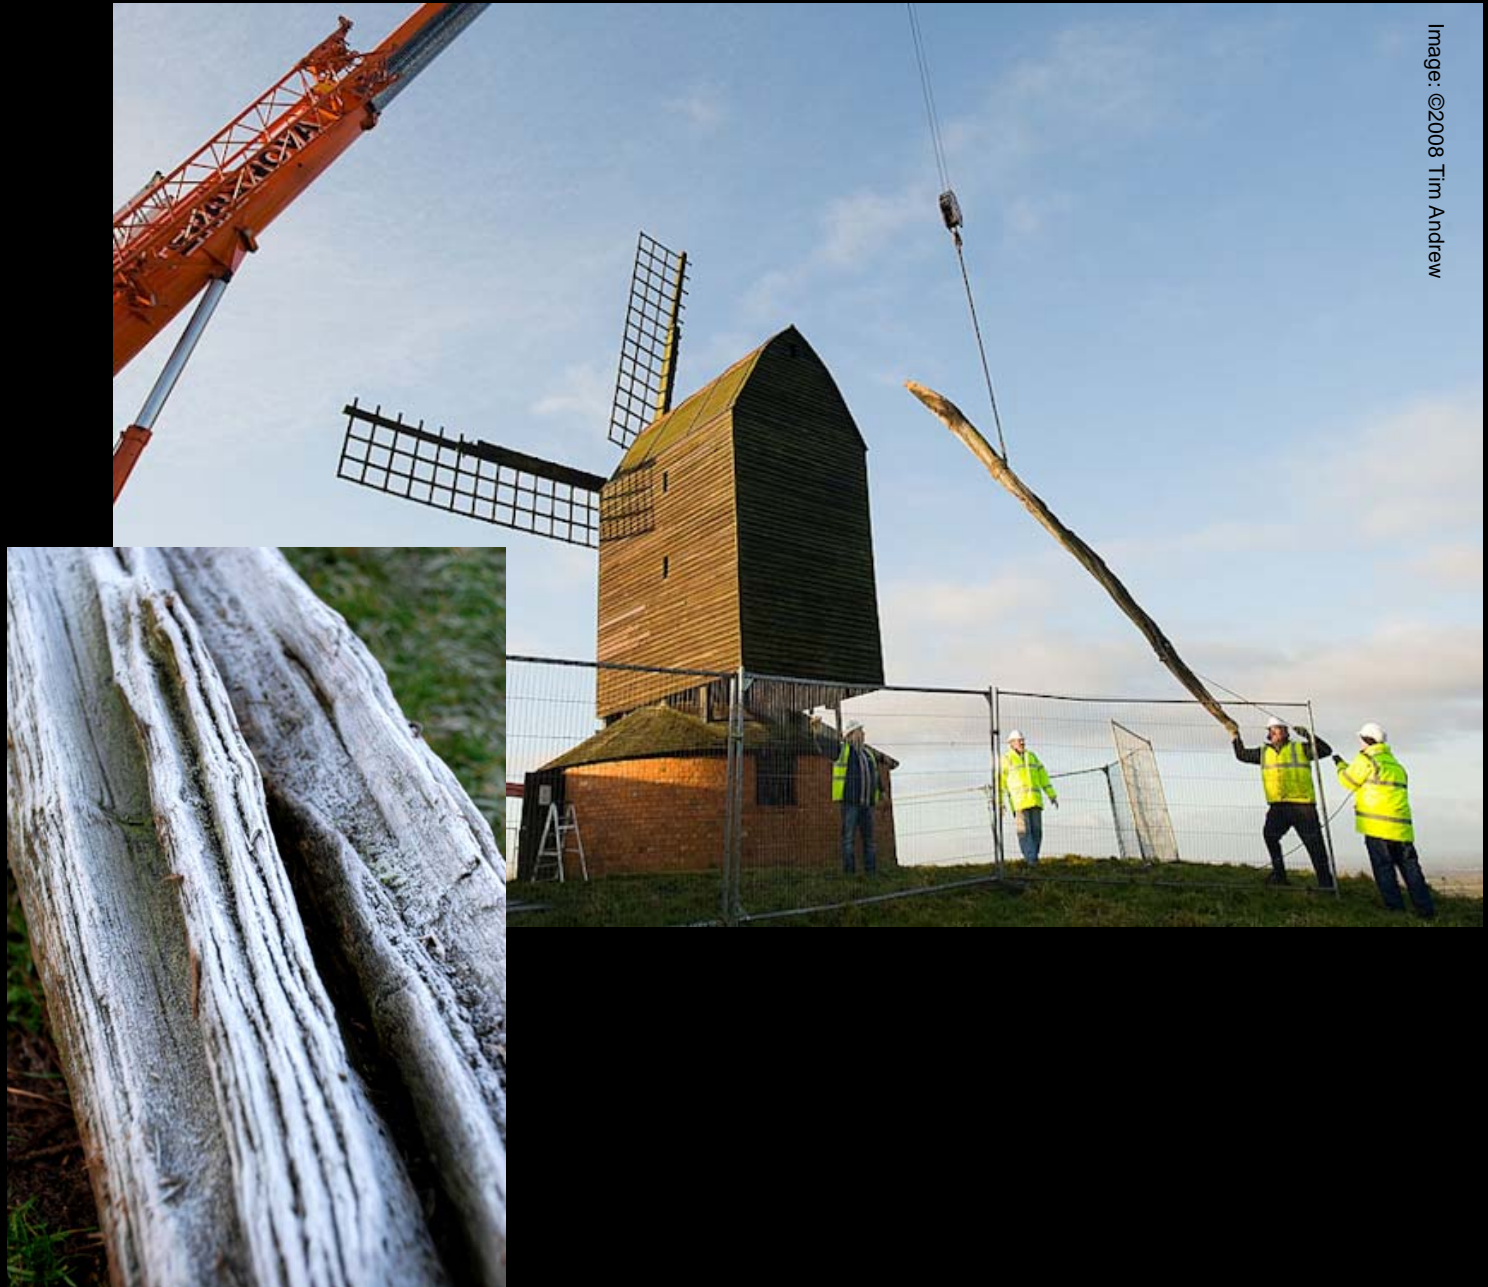
Works now focus on the removal of the mill's sails.

The works have been made easier by the use of a crane.

However, to allow the removal of each sail, each has to be rotated into an upright vertical position before being unbolted (with access gained by a 'cherry picker') and then slowly lifted up and away by a waiting crane.

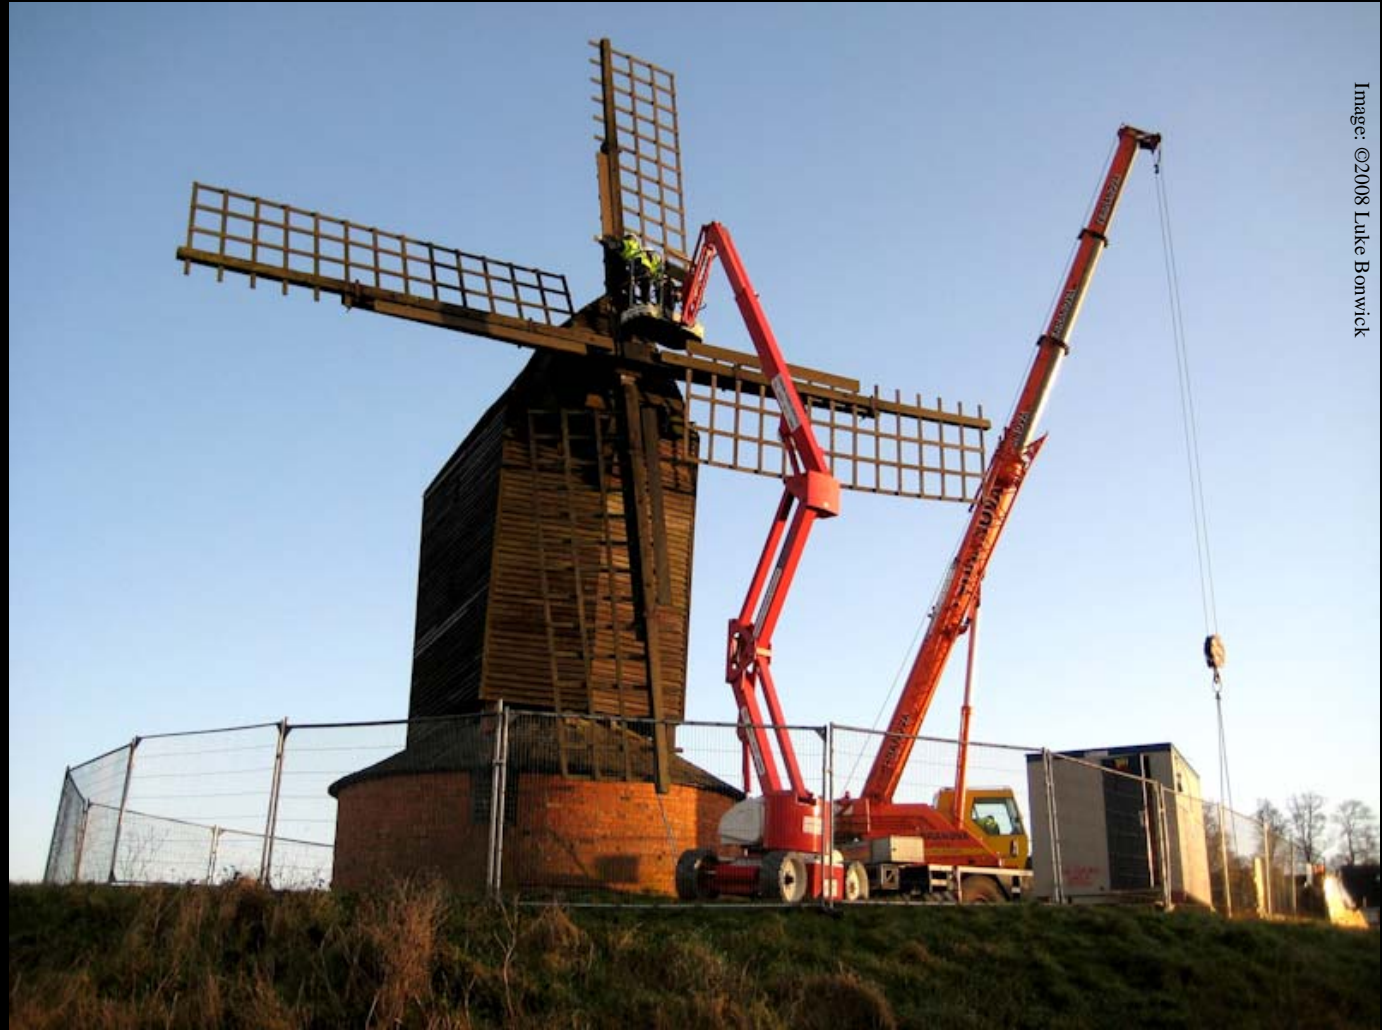
The last of the four sails is positioned into the vertical position to allow removal.

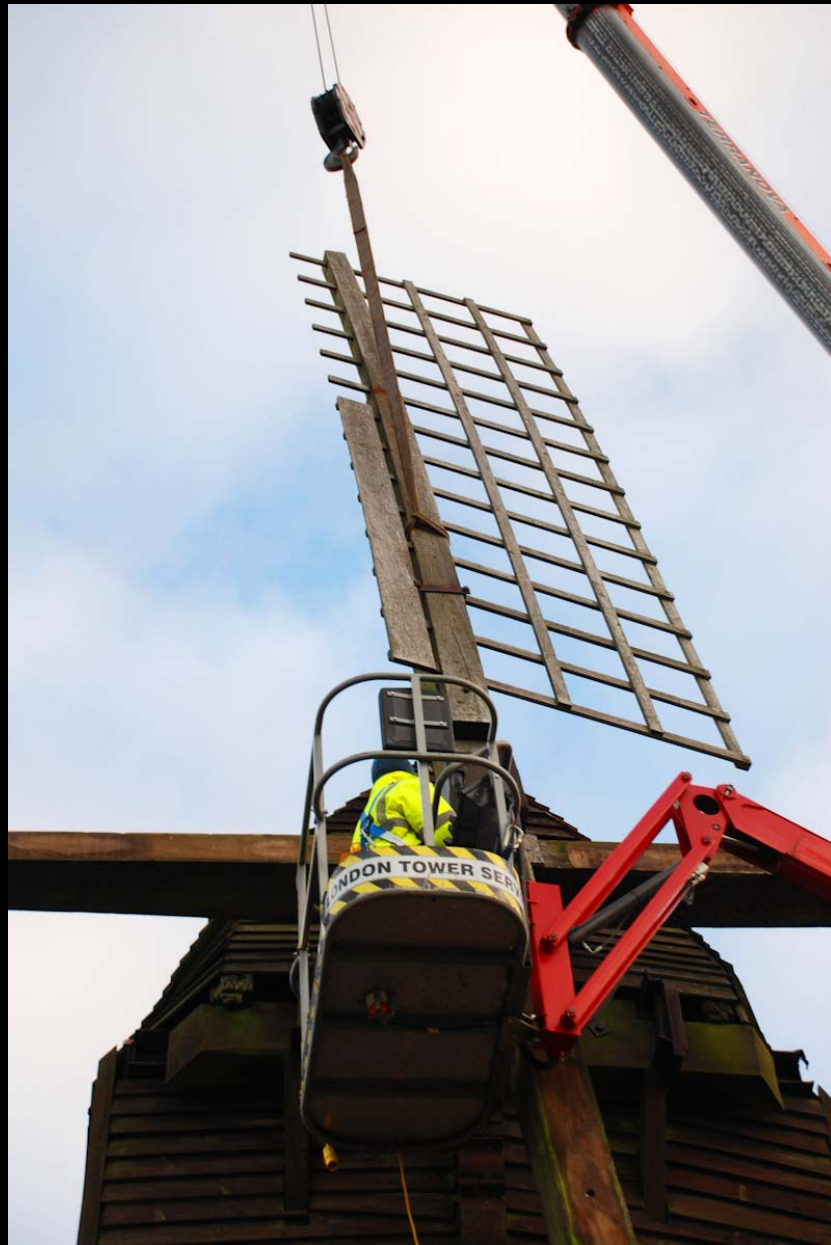
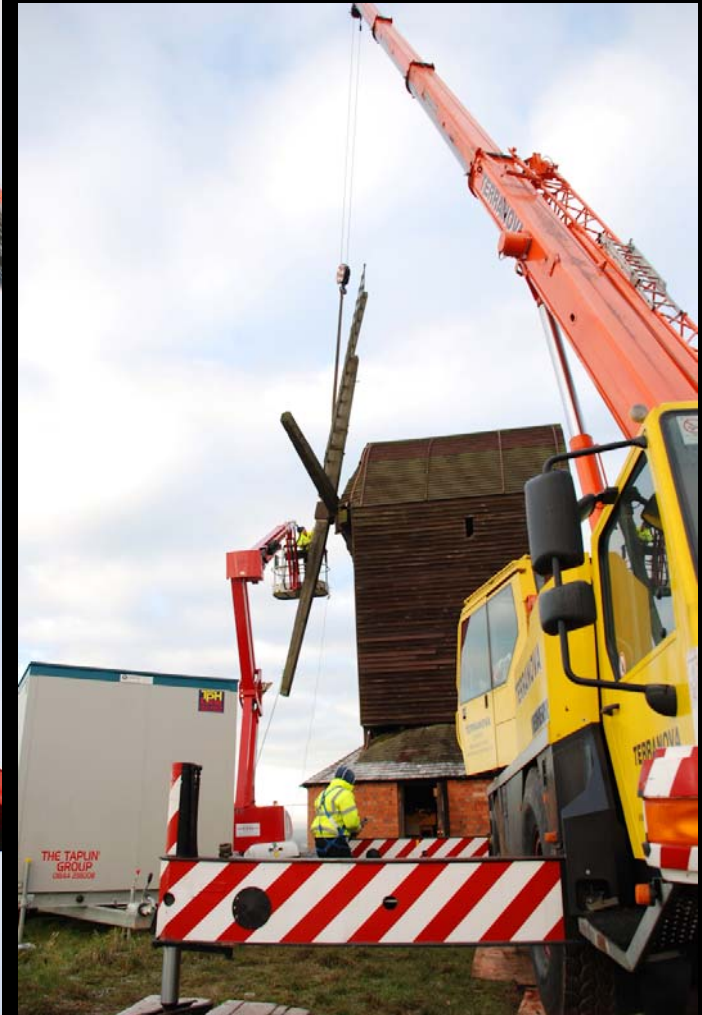
Works can now concentrate on the installation of scaffolding and the removal of the remaining sail 'stocks'
